National Dam Inspection Program. Wild  
Creek Dam, Carbon County, Pennsylvania  
(National I.D. Number PA-00609),  
Delaware River Basin, Wild Creek, Carbon  
County, Pennsylvania,

Phase I Inspection Report,

WILD CREEK DAM  
CARBON COUNTY, PENNSYLVANIA  
NATIONAL I.D. NO. PA 00609

## PHASE I INSPECTION REPORT NATIONAL DAM INSPECTION PROGRAM

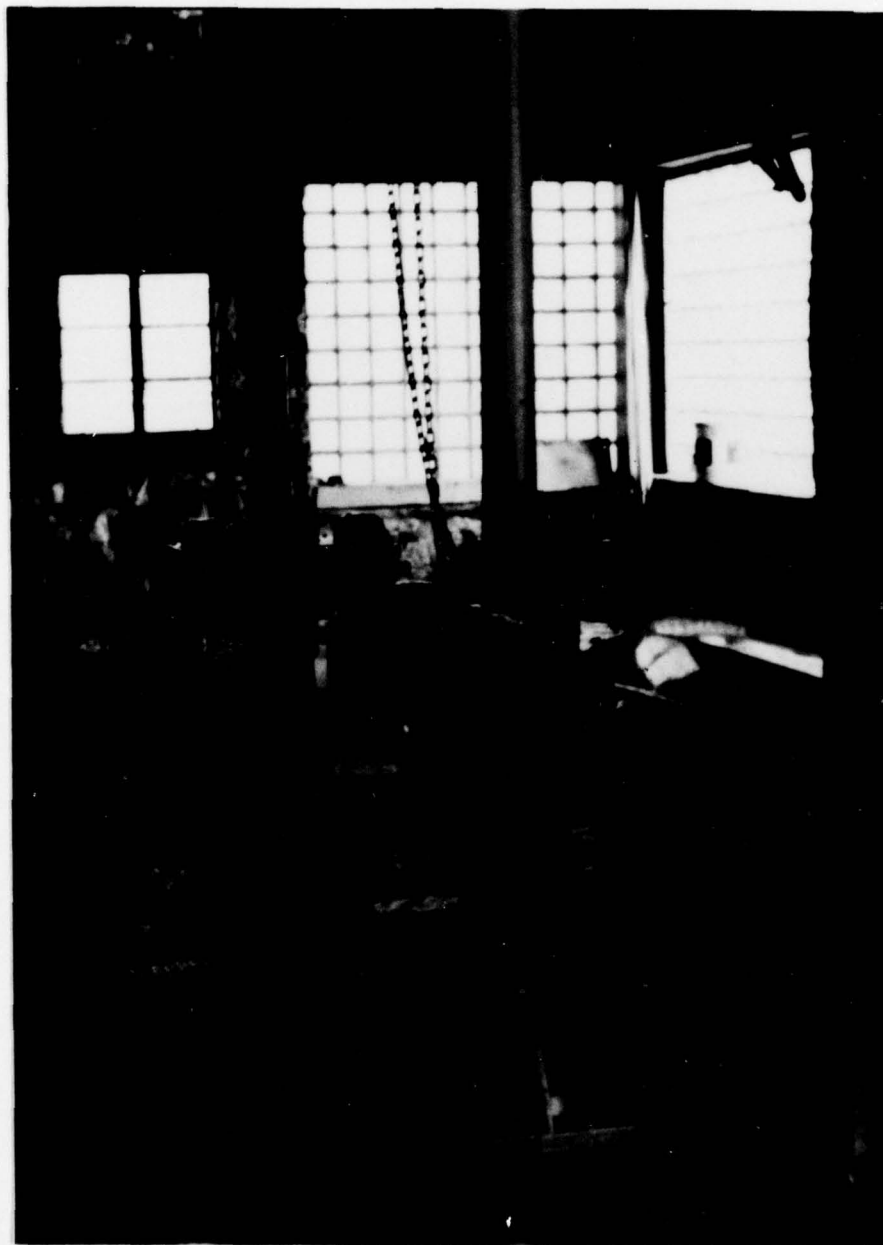
PHOTO NO. 2

The valve control mechanisms and the intake tower are clean; painted and lubricated as needed to insure proper operation and indicate periodic maintenance. All valves in the intake tower were exercised and appeared to operate properly. Valves in the Chemical Building were not inspected. The emergency reservoir drain valve was not exercised but appeared to be in good condition.

VIEW INSIDE TOWER LOOKING AT WATER SUPPLY  
CONTROL VALVES. EACH VALVE WAS EXERCISED  
BY THE PLANT OPERATOR.

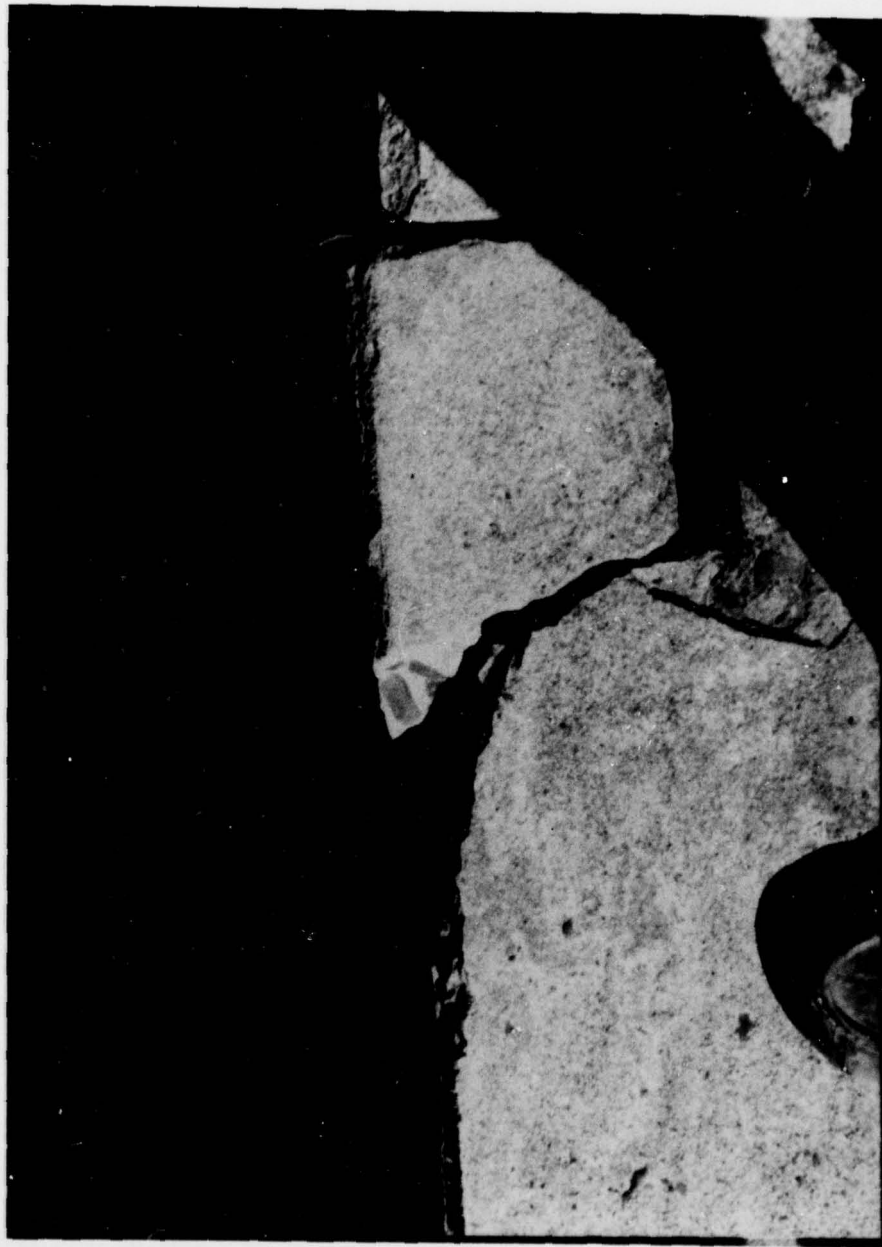
PHOTO NO. 7

c. Appurtenant Structures. At the time of the inspection, not more than one inch of water was flowing over the spillway. The spillway flow was observed to be smooth and uniform over the crest and down the spillway channel. As shown on Photos 3 and 4, vertical cracks were observed midway between construction joints and two compression cracks were observed at construction joints (Photos 6 and 7). All other portions of the spillway are in excellent condition.

a. Visual Observations. The visual observations did not indicate any existing embankment stability problems. The visual inspection of the spillway walls revealed several vertical cracks between construction joints and two compression spalls that do not appear to be detrimental to the stability of the walls.

LEFT RETAINING WALL OF EMERGENCY SPILLWAY LOOKING DOWN  
AT COMPRESSION FAILURE AT CONSTRUCTION JOINT. SPILLWAY  
CHANNEL IS LOCATED AT TOP OF PHOTO. TWO JOINTS OF THIS  
NATURE WERE OBSERVED.

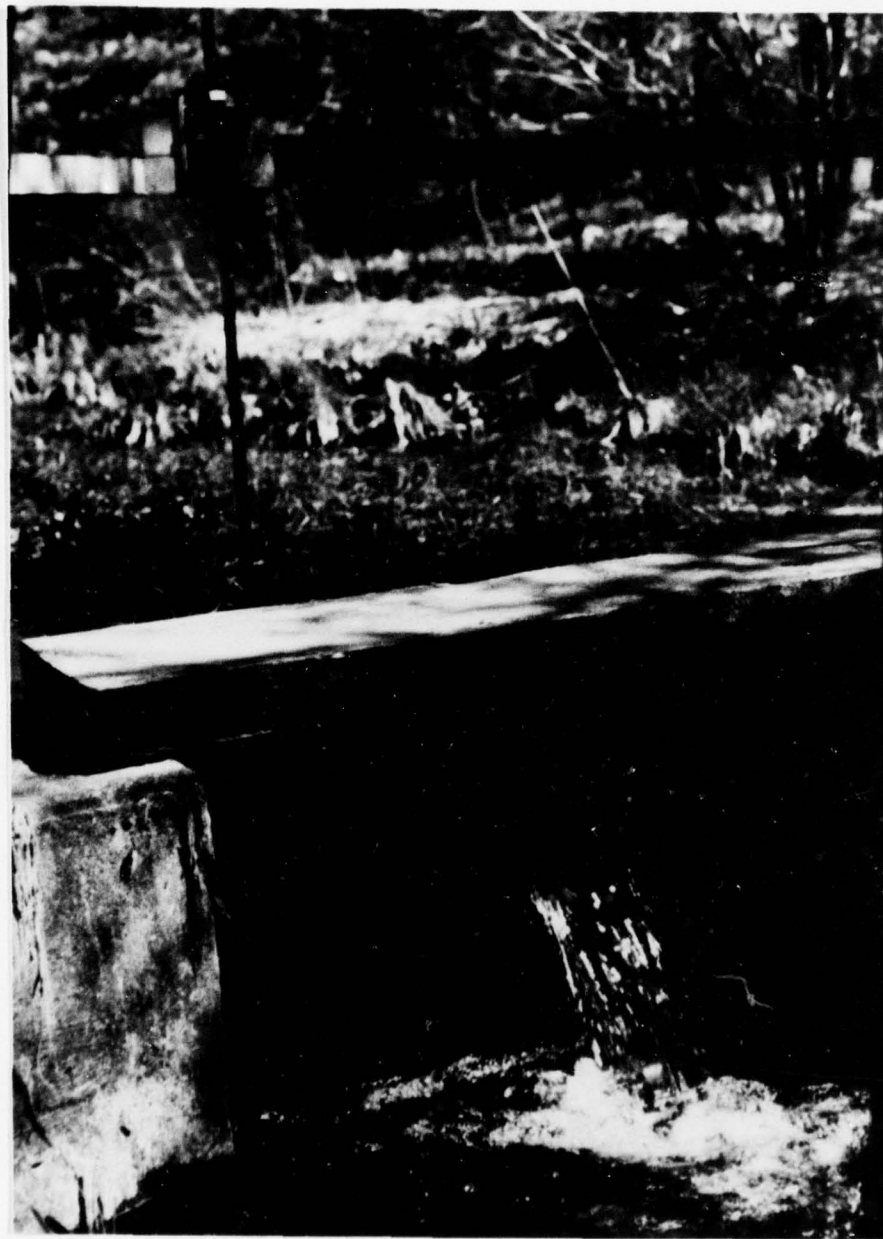
VIEW OF "V" NOTCH WEIR LOCATED DOWNSTREAM  
OF DIVERSION TUNNEL OUTLET STRUCTURE.
